St Edmund's ceiling repair and redecoration – report 2 – 12 June 2020

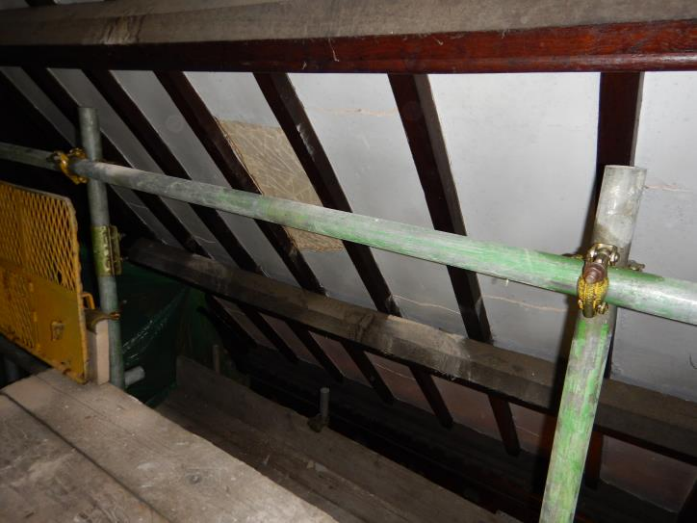
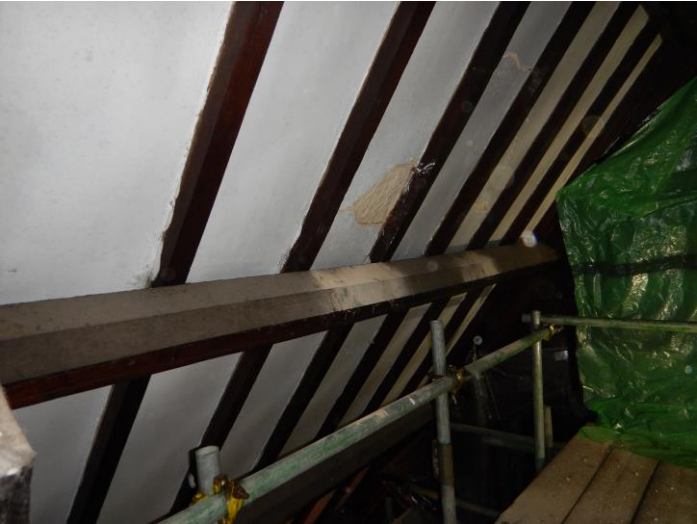
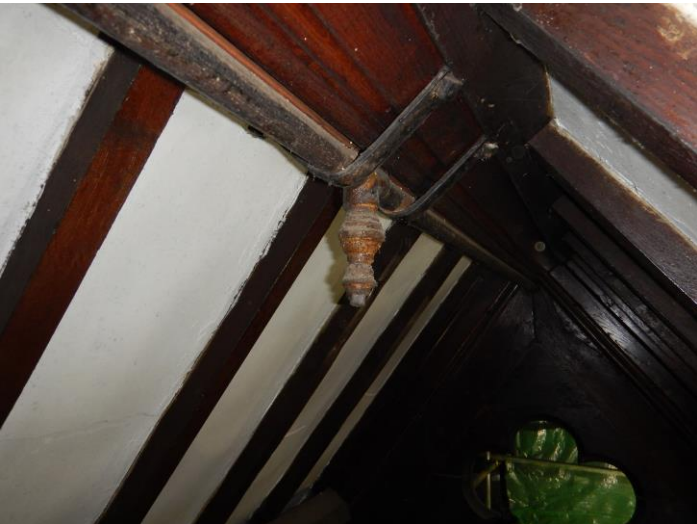
I attach a couple of pictures (on next page) showing the initial stage of building-up new plaster within damaged areas and of similar treatment in some of the plaster cracks. I discovered that the trusses have several different designs of carvings including these rather nice oak leaves, lofty and rarely appreciated pieces of work. A piece of timber moulding on the left has fallen away, leaving the nail exposed, but no-one seems to have missed it. The last photo shows part of the former gas lighting system, remnants of which and the holes for its fixings remain around the roof.

The plasterer has started working on these defects, cutting out the damaged material and gradually building up the new surfaces. He expects to complete this by the end of the weekend. I went up today (Friday) to see what he has done and it looks like good work in progress. During his inspection the Architect found no signs of woodworm in the parts of the roof visible from inside so we will not be carrying out any treatment work on the roof. He did however find in several places some felt-like material within various enclosed areas which may possibly contain asbestos fibres. He has contacted a specialist surveyor from whom we are expecting a quotation early next week. I hope that we will be in a position immediately thereafter to instruct the surveyor to sample and analyse this material to see whether we have a problem or not.
