St Edmund's ceiling repair and redecoration – report 2 – 12 June 2020

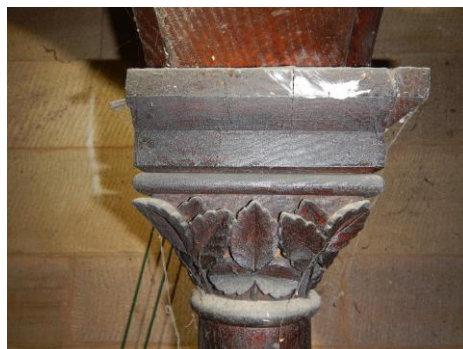
I attach a couple of pictures (on next page) showing the initial stage of building-up new plaster within damaged areas and of similar treatment in some of the plaster cracks. I discovered that the trusses have several different designs of carvings including these rather nice oak leaves, lofty and rarely appreciated pieces of work. A piece of timber moulding on the left has fallen away, leaving the nail exposed, but no-one seems to have missed it. The last photo shows part of the former gas lighting system, remnants of which and the holes for its fixings remain around the roof.

The plasterer has started working on these defects, cutting out the damaged material and gradually building up the new surfaces. He expects to complete this by the end of the weekend. I went up today (Friday) to see what he has done and it looks like good work in progress. During his inspection the Architect found no signs of woodworm in the parts of the roof visible from inside so we will not be carrying out any treatment work on the roof. He did however find in several places some felt-like material within various enclosed areas which may possibly contain asbestos fibres. He has contacted a specialist surveyor from whom we are expecting a quotation early next week. I hope that we will be in a position immediately thereafter to instruct the surveyor to sample and analyse this material to see whether we have a problem or not.
